Impacts of liquefaction and lateral spreading on bridge pile foundations from the February 22nd 2011 Christchurch earthquake

A thesis submitted in partial fulfilment of the requirements for the

Degree of Masters of Engineering in Civil Engineering

at the University of Canterbury

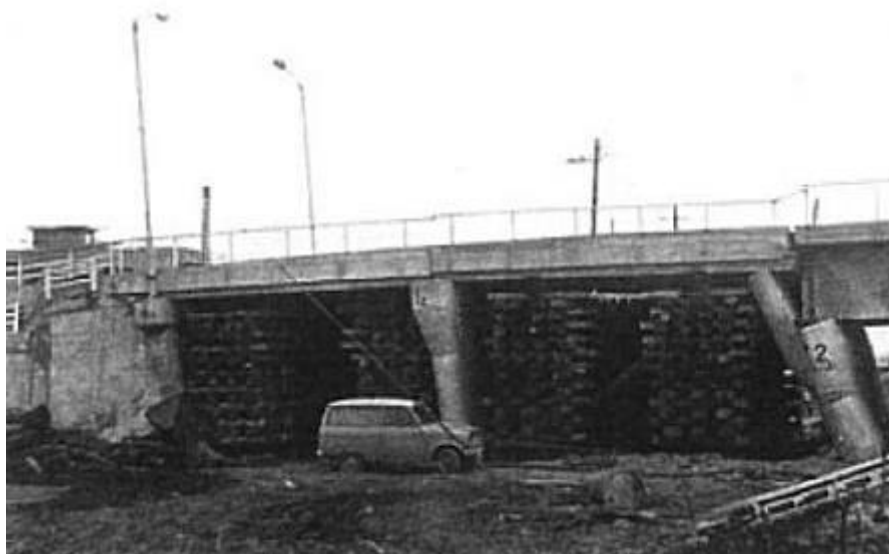
Figure 2-4: Damage to the abutments and piers of Yachiyo Bridge (Hamada and O'Rourke 1992)

Another bridge damaged in the Niigata earthquake was the Yachiyo Bridge, a 14-span structure with a simply-supported pre-stressed concrete deck. Liquefaction-induced lateral spreading was in the order of 4 metres on both river banks (Hamada and O'Rourke 1992), and the pile-supported abutments and piers suffered substantial damage, as can be seen in Figure 2-4. The foundation piles themselves also sustained severe damages at the interface between the liquefied and non-liquefied layers (Hamada and O'Rourke 1992), and horizontal cracks were found throughout the piles indicating large bending moment demands. The large unilateral ground displacements towards the river pushed the bases of the piers in that direction, however their movement at the top was restrained by the stiffness of the bridge deck. This induced large pier back-rotations; the horizontal differential movement between the top and bottom of one pier was measured to be 1.1 m.

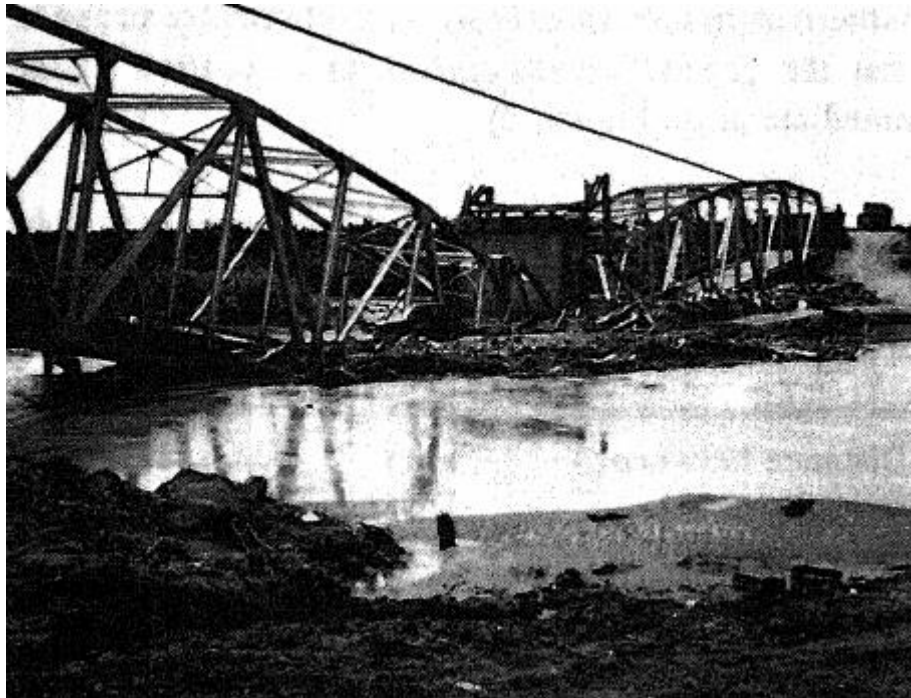
Figure 2-6: Rio Estrella Highway Bridge - collapse of truss sections from central pier (Youd et al. 1992)

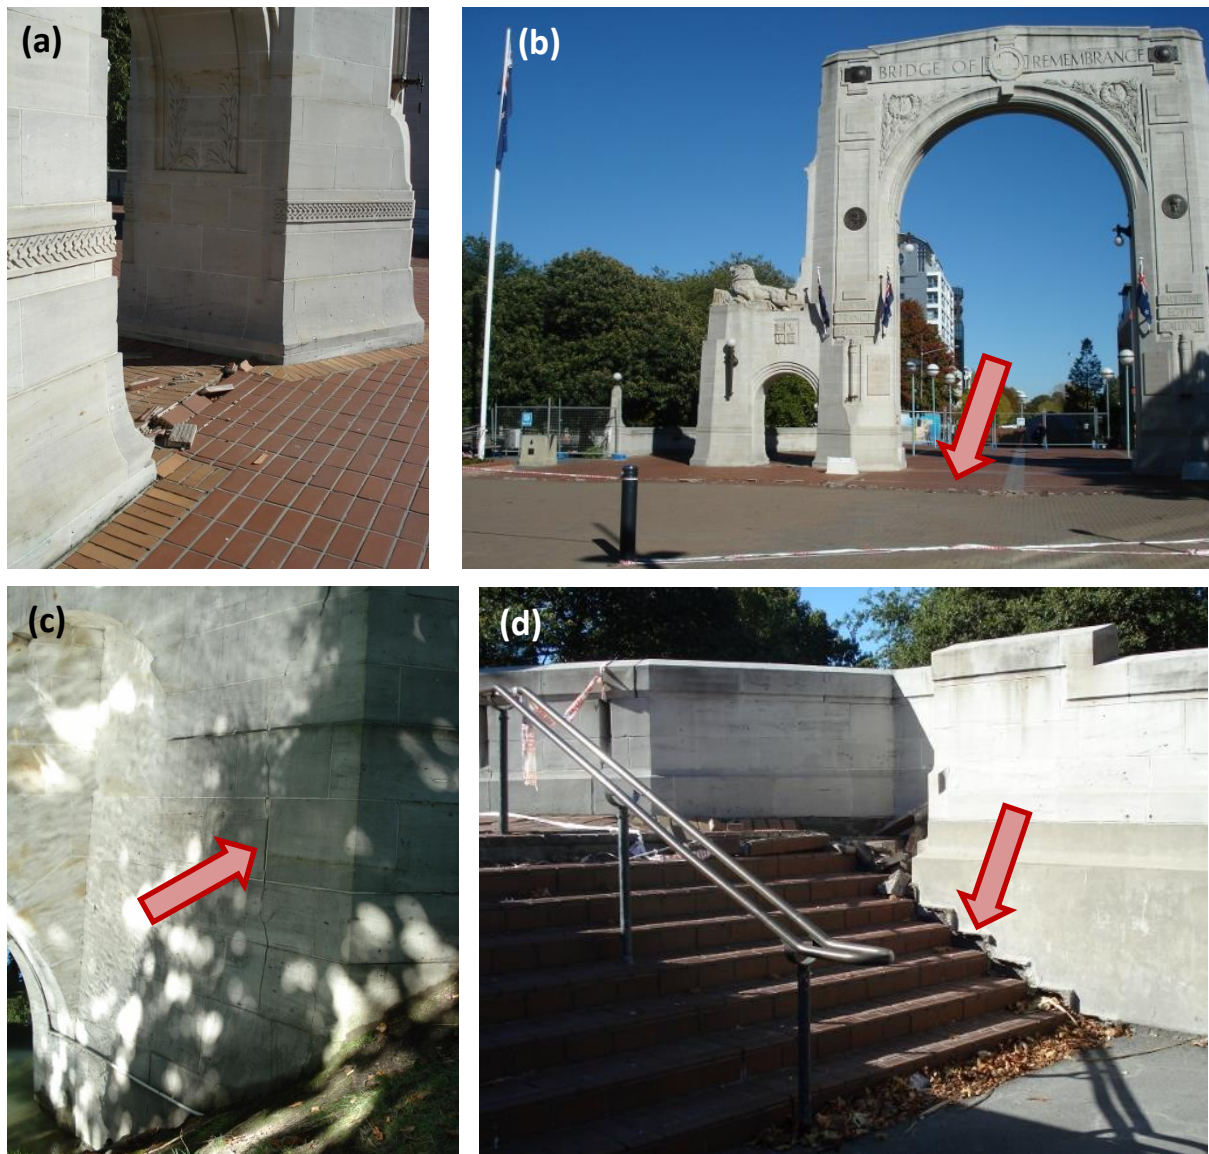
Figure 3-12: Observed damages to the Bridge of Remembrance following 22nd February earthquake: (a) compression cracking in pavement underneath Triumphal Arch, (b) compression cracking in pavement at eastern bridge/approach interface, (c) vertical cracking of wingwall, (d) vertical settlement of western approach visible at stairs

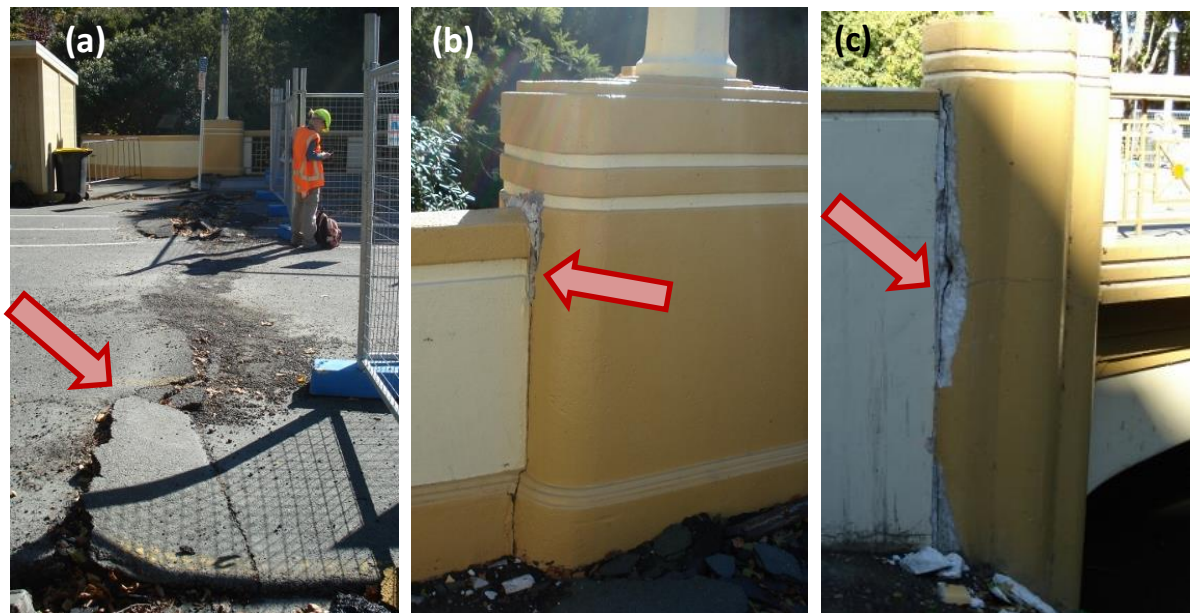
Figure 3-13: Hereford Street Bridge observed damages: (a) compression damage to western road approach, (b) separation of wingwall from bridge structure, (c) cracking between wingwall and bridge structure

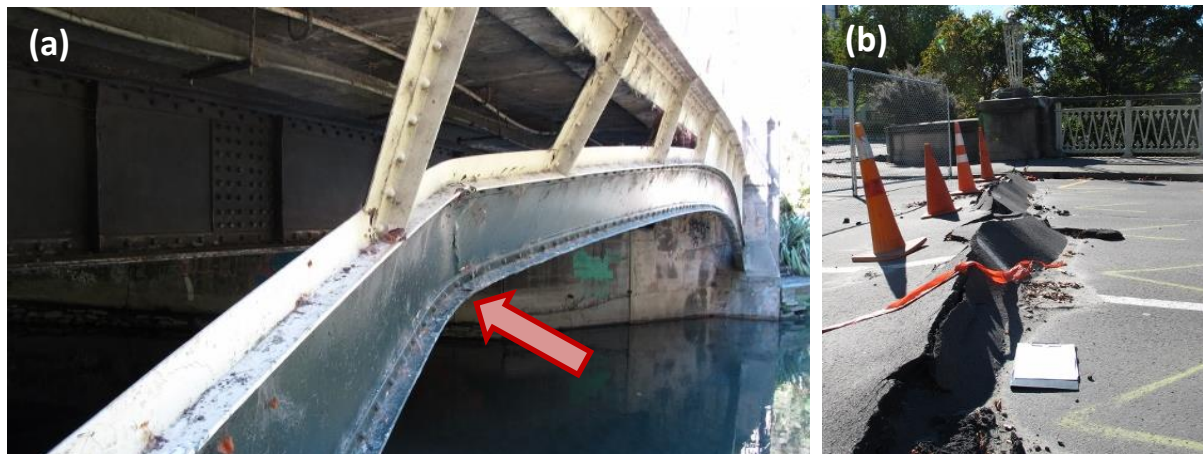
Figure 3-15: Colombo Street Bridge observed earthquake damages: (a) severe buckling of steel bridge arch, (b) compression damage to roadway approach

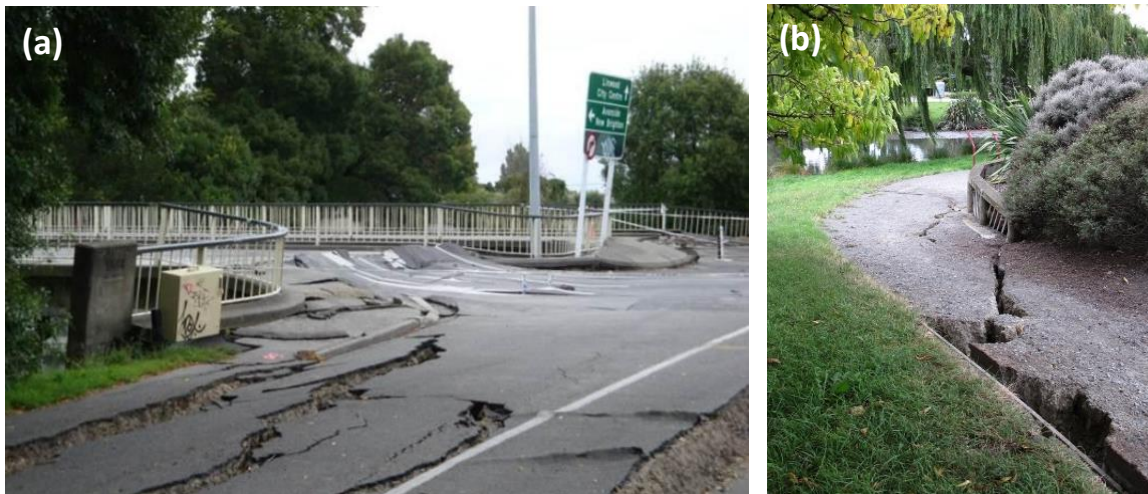
Figure 3-20: Land damage observed in the vicinity of Fitzgerald Ave Bridge, (a) significant cracking and slumping of northern approach, (b) lateral spreading cracks to the immediate west of the north abutment

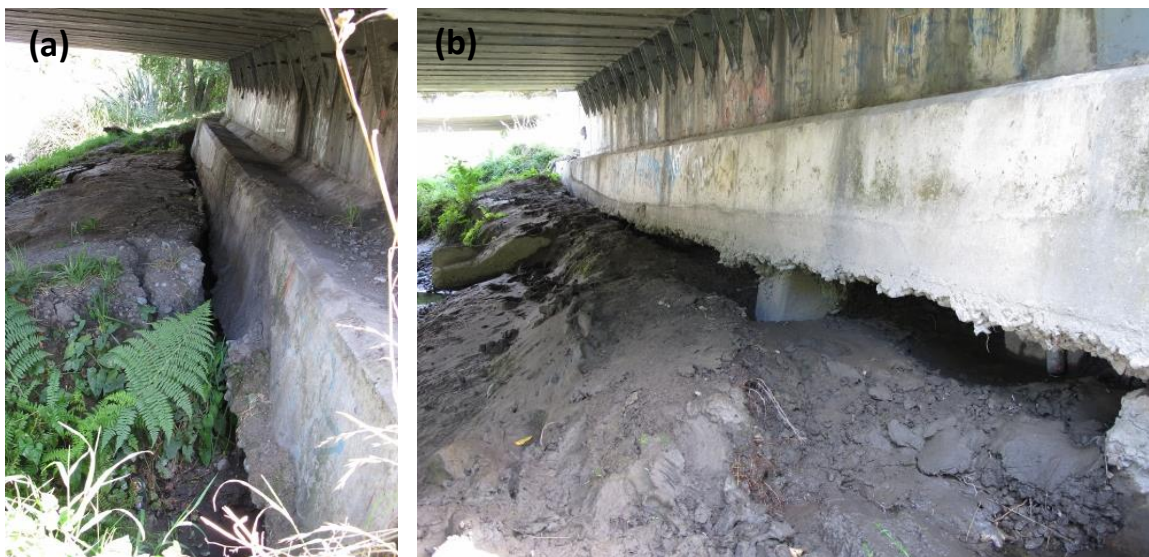
Figure 3-22: Fitzgerald Bridge north abutments, (a) western bridge, (b) eastern bridge

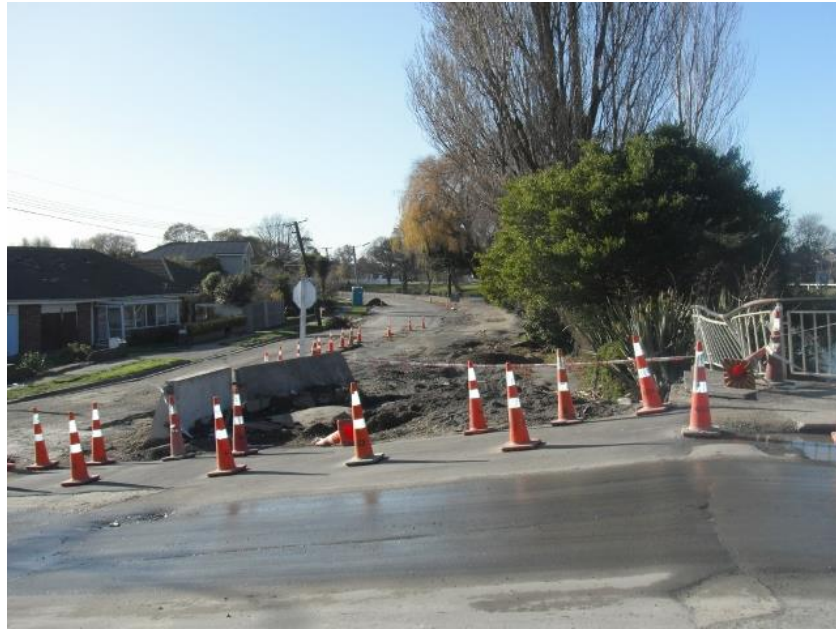
Figure 3-26: Settlement of northern approach of Dallington Bridge, resulting in steepening of approach road.

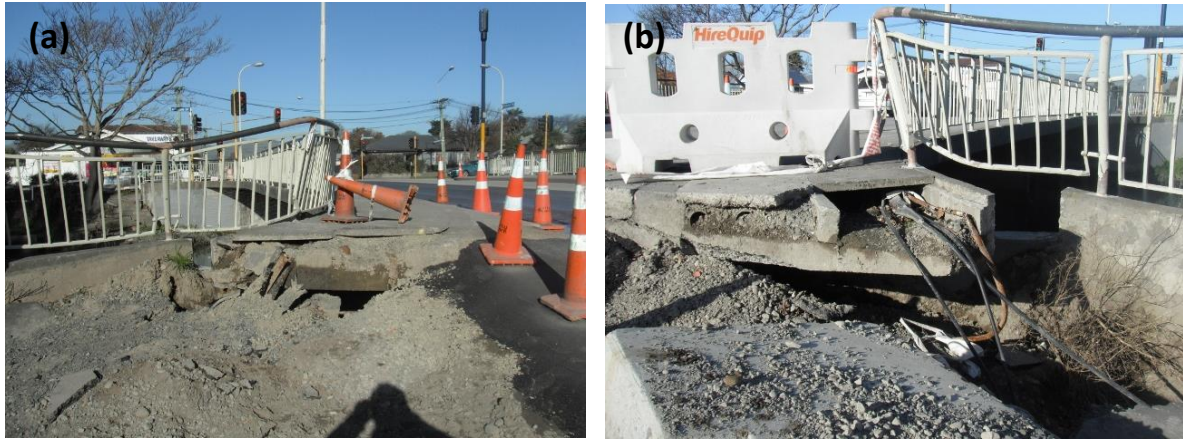
Figure 3-27: North abutment, Dallington Bridge looking south, (a) eastern side showing settlement of approach from bridge deck and exposed services, (b) western side showing translation and rotation of wingwall, settlement of approach and exposure of services.

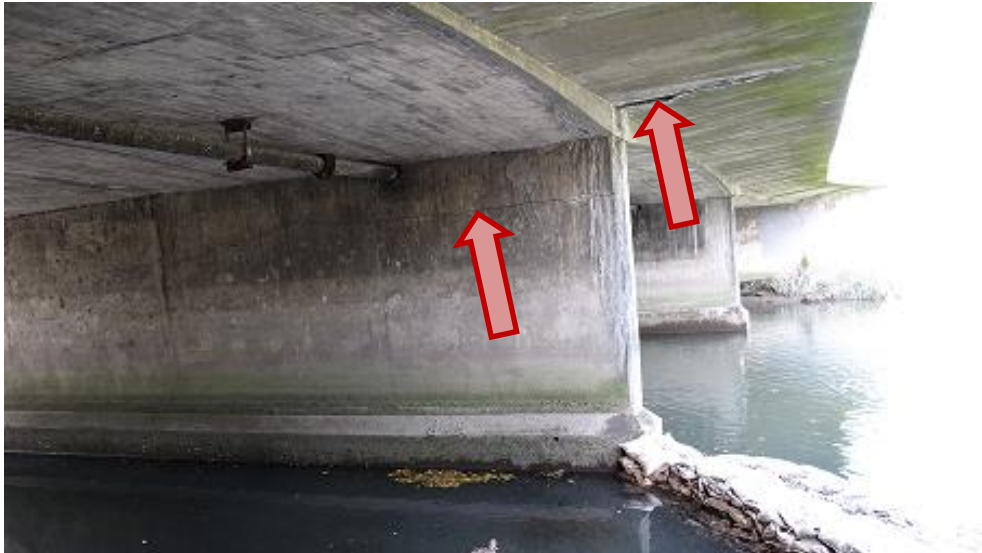
Figure 3-29: Dallington Bridge, looking south, horizontal cracking in northern pier, horizontal cracking on underside of pedestrian cantilever.

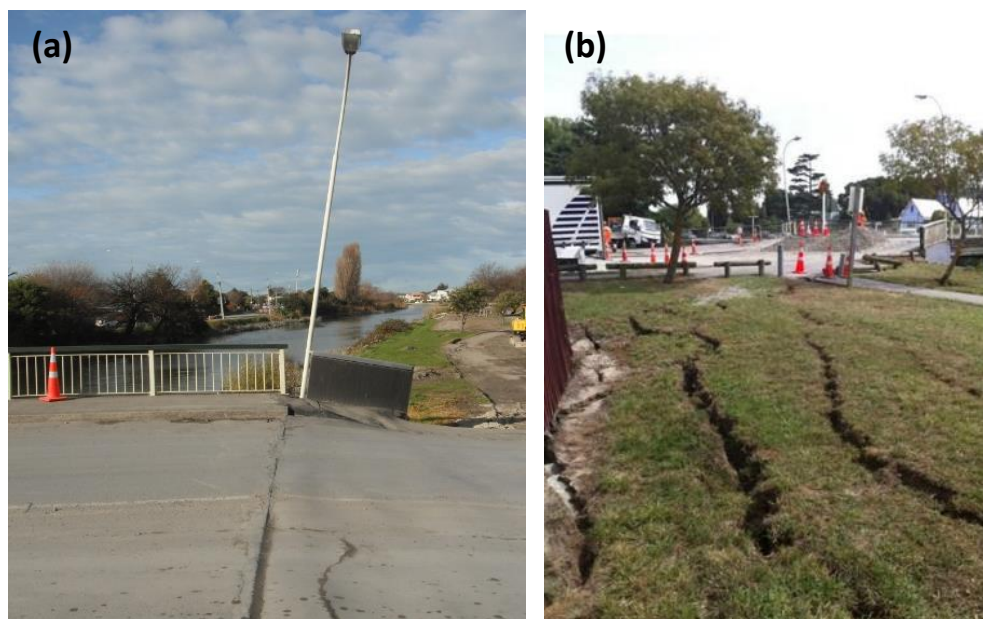
Figure 3-34: Avondale Road Bridge south abutment, (a) observed ground settlement leading to steepening of approach road, (b) lateral spreading cracks observed immediately to the east of the south abutment.

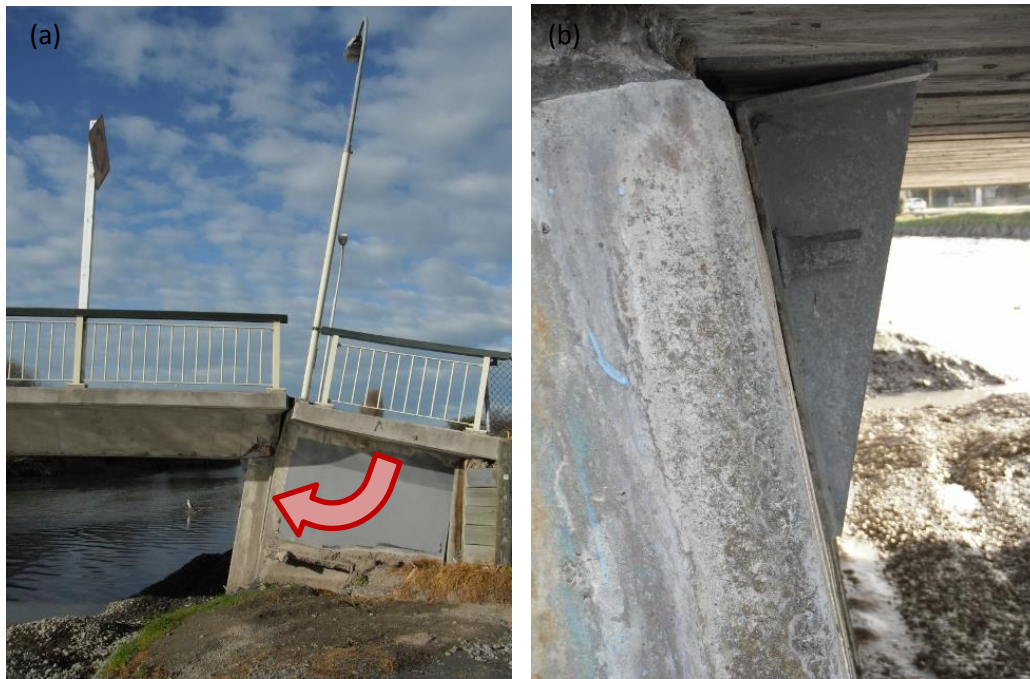
Figure 3-35: Avondale Road Bridge south abutment, (a) back rotation of abutment, (b) observed gapping between steel bracket and bridge deck.

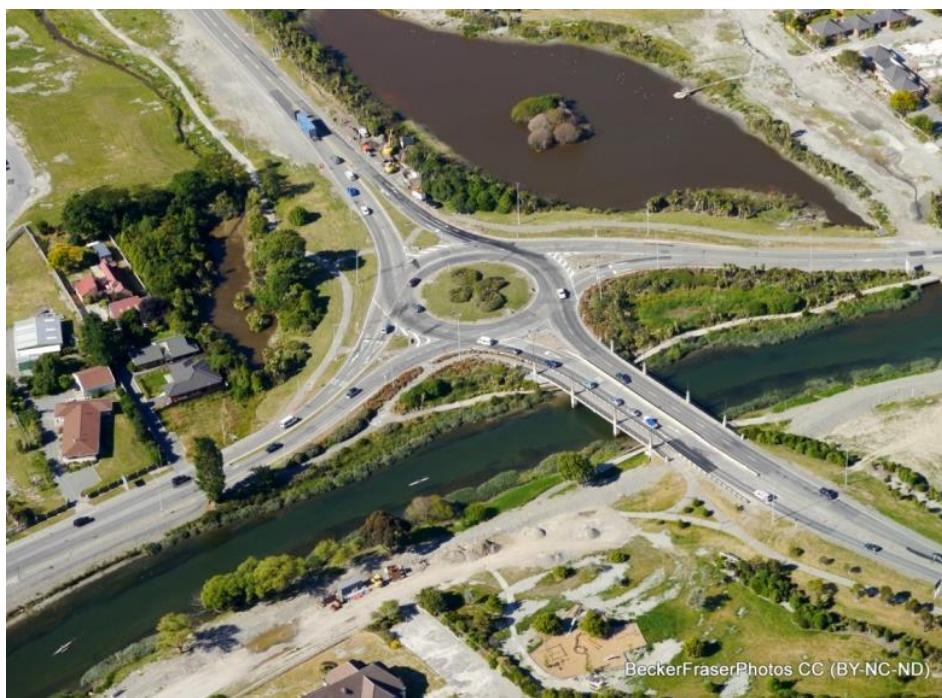
Figure 3-37: Aerial view of ANZAC bridge (looking towards the north-east) subsequent to the Christchurch earthquake (Becker-Fraser photos)

Marginal liquefaction and lateral spreading occurred in the area of the bridge during the Darfield earthquake, such that the bridge and its functionality were not at all affected (Wotherspoon *et al* 2011). The Christchurch earthquake, on the other hand, saw significant liquefaction and lateral spreading occur at the bridge site. Figure 3-37 shows the extent of liquefaction ejecta, clearly more severe on the south bank than the north.

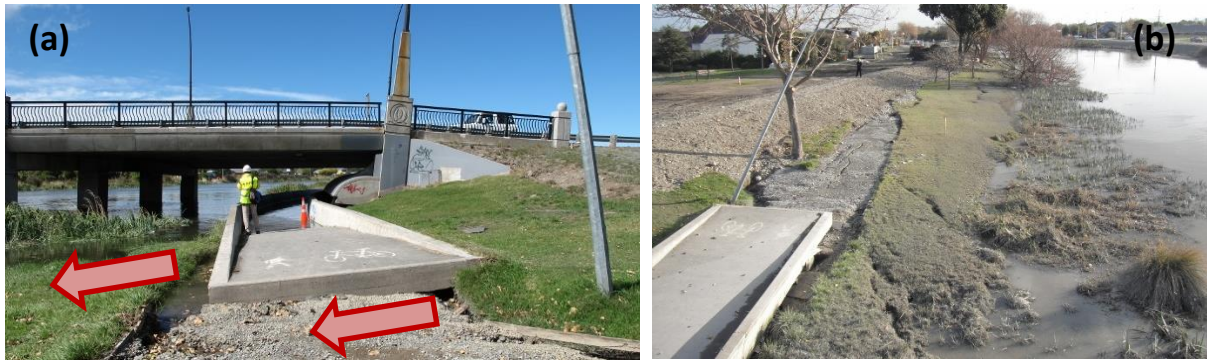
Figure 3-38: Ground cracking and slumping in direction of river, southern abutment, ANZAC Bridge (a) looking east, (b) looking west from the bridge

There were a significant number of sand boils observed in the grassy areas on either side of the southern bridge approach and large lateral spreading fissures were observed running parallel to the river-bank (see Figure 3-38). Lateral spreading transects performed near the bridge indicate that the free-field displacement of the ground towards the river ranges between 0.9–1.1 m (see Figure 3-41). These values were also confirmed by LiDAR measurements. Figure 3-42b shows the distribution of cracks with distance from the river as measured in the transect performed immediately to the west of the abutment. This indicates one large crack (~0.5 m wide) 8 metres from the river bank, followed by a succession of cracks gradually decreasing in width and increasing in spacing extending back further than 100 m from the river bank. Ground settlement led to steepening of the approach road and, as can be seen in Figure 3-39, induced severe pavement compression cracking at the deck/approach interface. Smaller pavement and ground cracks were also apparent running perpendicular to the river on both sides of the approach suggesting that the approach fill slumped away from the roadway as well as towards the river.

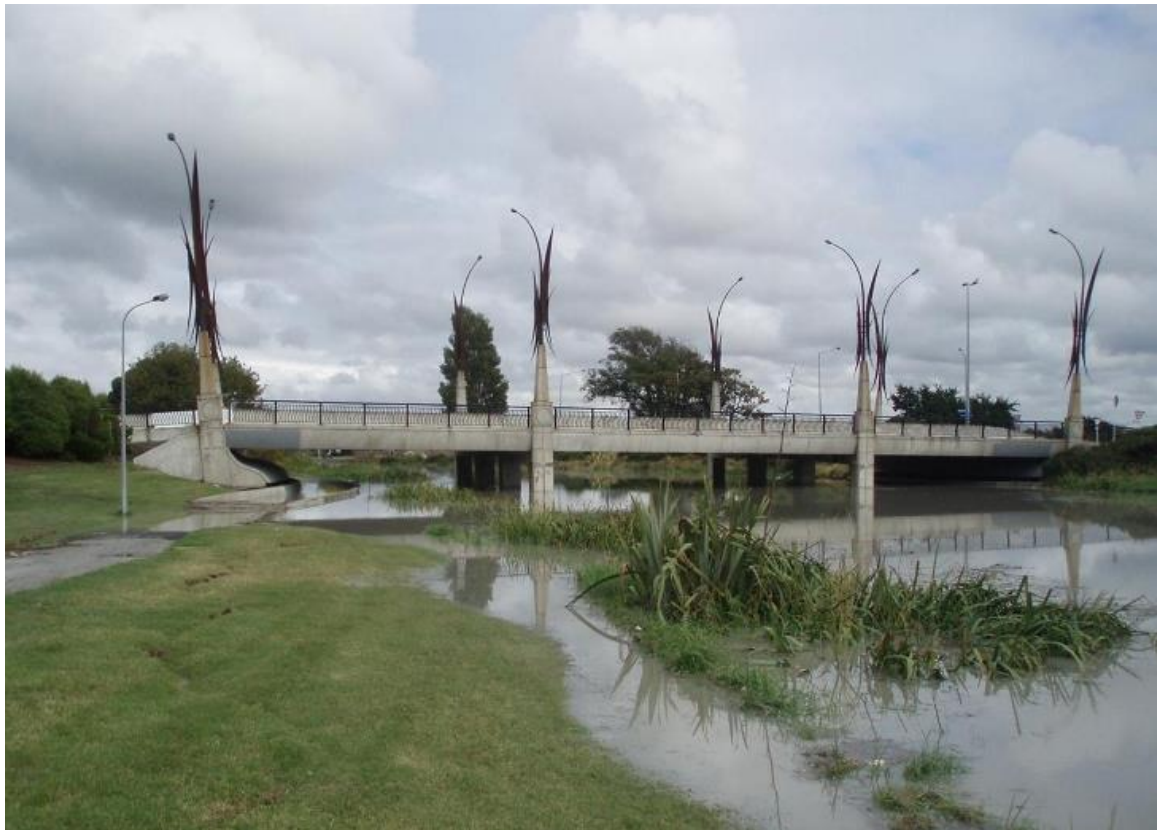
Figure 3-43: ANZAC Bridge, 24 February 2011, showing elevated water levels and spreading-induced damage mechanism

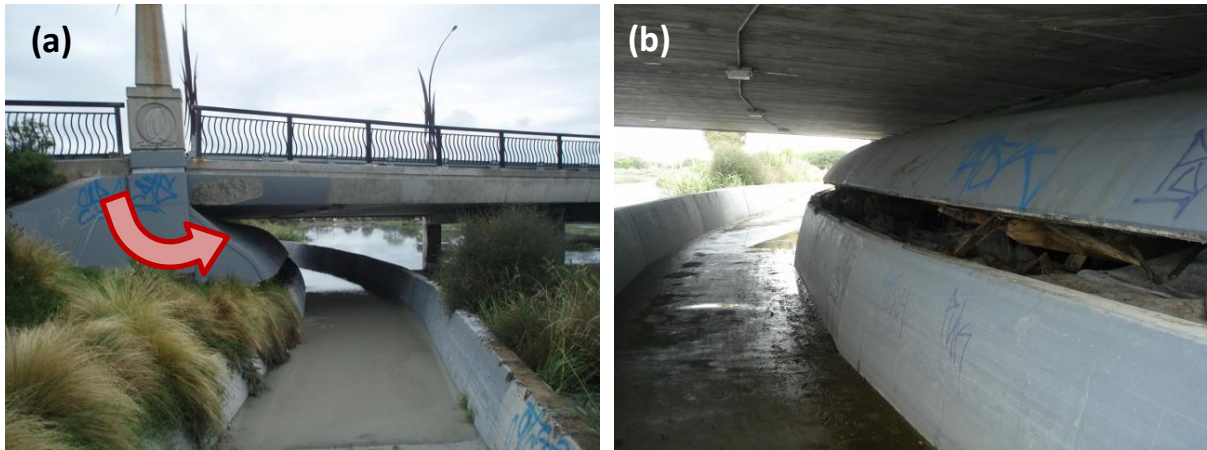
Figure 3-45: ANZAC Bridge north abutment (a) back-rotation of abutment, (b) separation of underpass from abutment

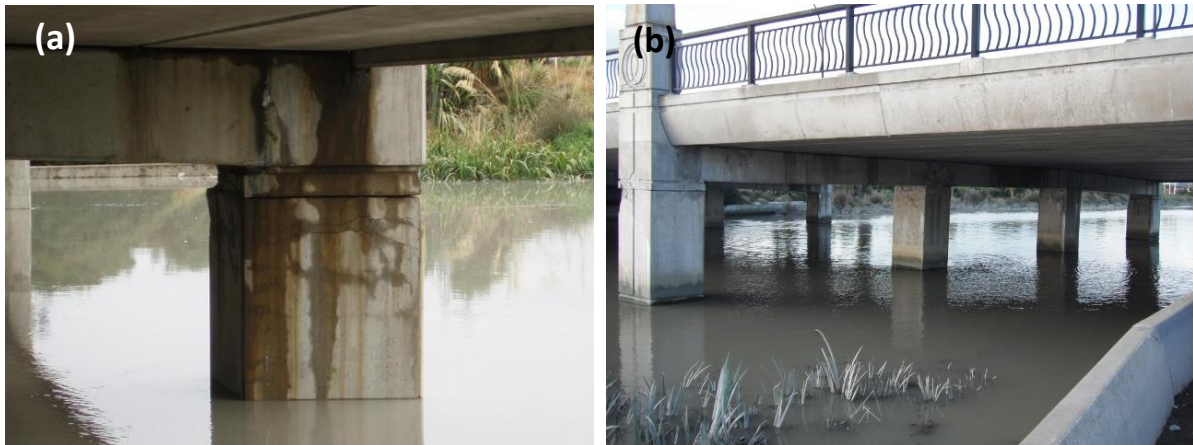
Figure 3-46: ANZAC bridge pier damage, (a) concrete spalling on southern pier column, (b) back-rotation of southern pier group

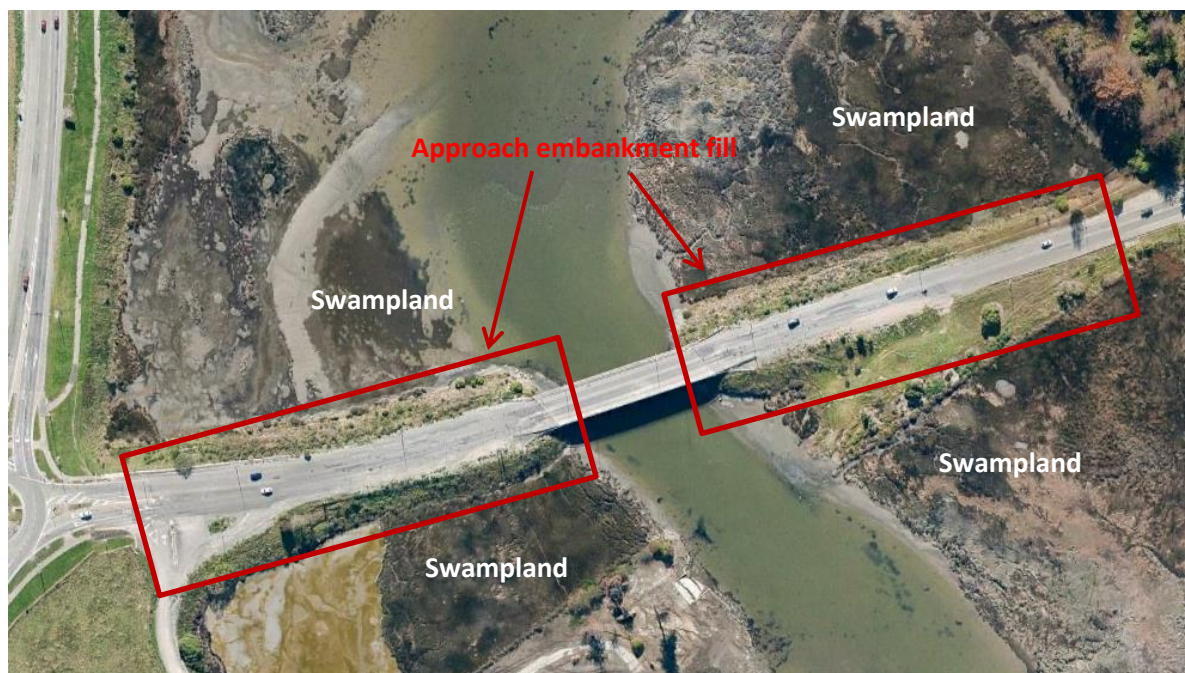
Figure 3-51: South Brighton Bridge and surroundings, highlighted are the constructed fill embankments and natural swampland on all sides

Prior to bridge construction the site was originally a wetland, typical of a highly liquefaction-prone area. As a result, extensive infilling was required such that approach embankments were constructed on both sides of the river extending inland up to 200 metres on either side. At the river banks this approach fill is approximately 4 metres high. On either side of both approach embankments swampland still predominates as can be seen below in Figure 3-51.

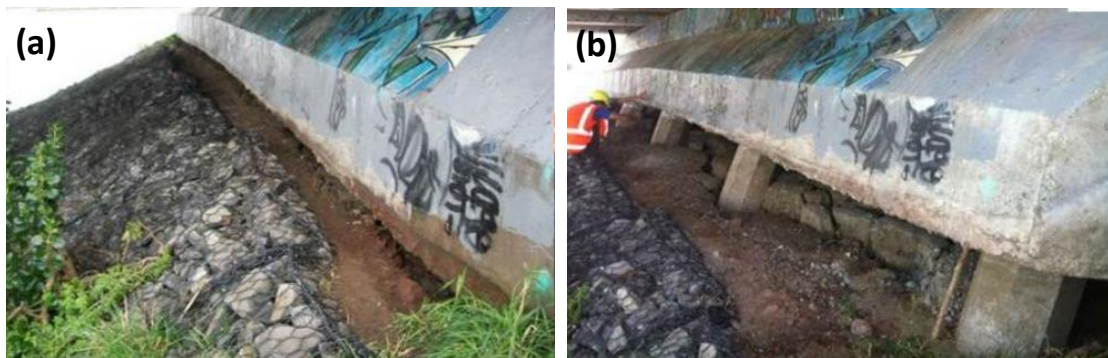
Figure 3-58: South Brighton Bridge east abutment, comparison of the soil displacement under east abutment after the (a) Darfield and (b) Christchurch earthquakes (GEER 2011).

South Brighton Bridge demonstrated the typical spreading-induced deck-pinning/abutment back-rotation mechanism and associated damages. Some damages were initiated following the Darfield earthquake, however presented below are the cumulative effects of both the Darfield and Christchurch events combined, due to reconnaissance works being undertaken following the Christchurch earthquake. Figure 3-58 below, photos taken by members of the GEER reconnaissance team following the Darfield and Christchurch events, shows a comparison of the soil displacements observed under the east abutment as a result of these two significant events. It can be seen that, even though approach settlement and lateral displacement was initiated in the Darfield event, the ground movements after the Christchurch event were much larger both in magnitude and severity.

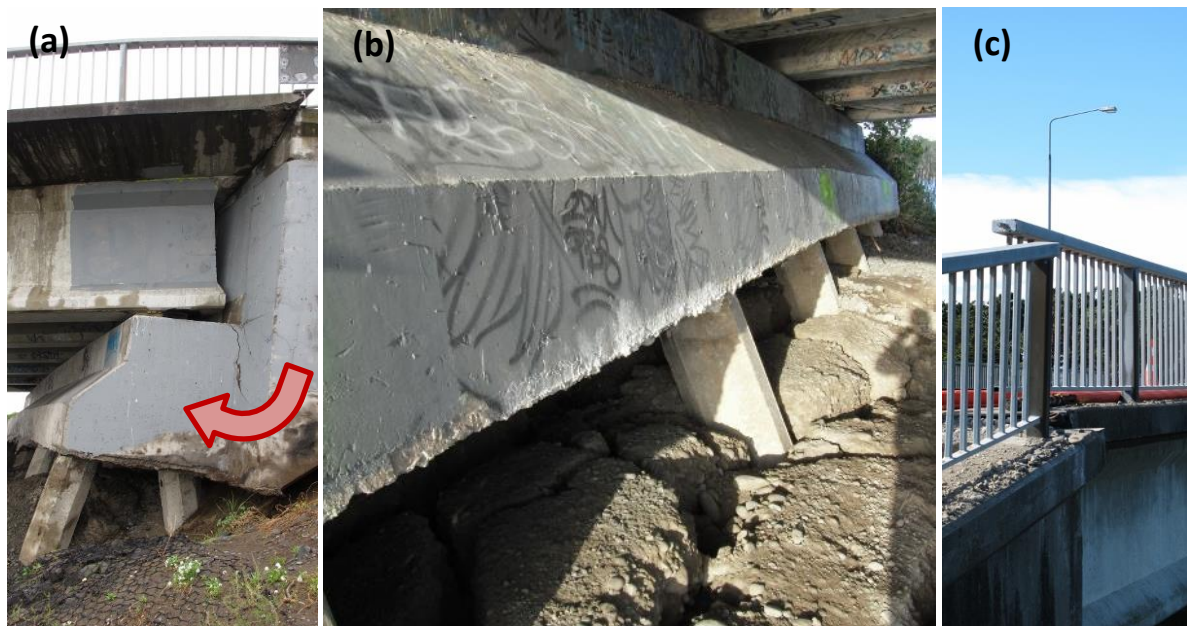
Figure 3-59: South Brighton Bridge abutment back-rotation, (a) west abutment (north face), (b) east abutment looking southeast, noticeable land cracks shown, (c) skewed movement of southwestern approach relative to bridge deck.

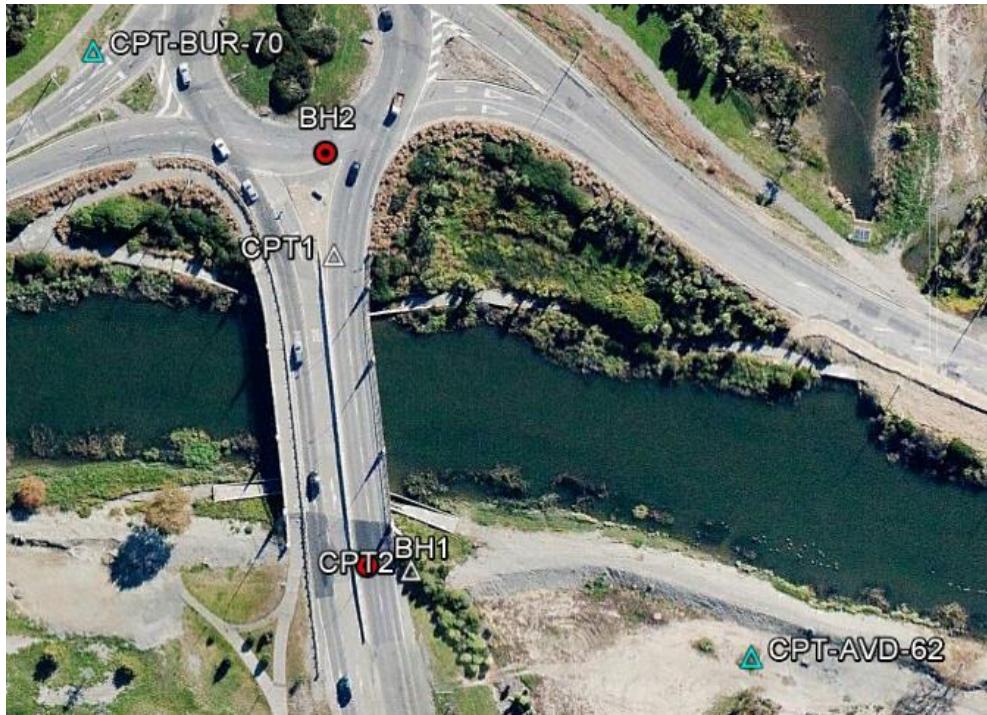
Figure 5-8: ANZAC Bridge site investigation locations (Google Earth image)

Prior to the bridge's construction a site investigation was carried out consisting of an SPT and CPT at each abutment (BH1 & 2, CPT1 & 2 in Figure 5-8). Two additional CPTs commissioned by the EQC as part of their greater Christchurch ground investigations are located near ANZAC Bridge (CPT-BUR-70 and CPT-AVD-62), however these were not considered to be of use for this research for two key reasons. First, they were carried out in November 2011 meaning that they are unlikely to be representative of pre-quake conditions due to the area having been disturbed several times in the 2010-2011 earthquake sequence. Secondly, their distance from the bridge itself is quite large (each of them around 50 m) and so due to the large variability in Christchurch soils they are unlikely to encounter strata entirely characteristic of those found at each abutment. CPT-BUR-70 in particular is more likely to be representative of the swamp land found further north of the bridge itself. Table 5-4 summarises the exact locations, dates of testing and other details of the geotechnical site investigations.
